# **Subway Line 2 Wheel Flats**

## **Status Update**

Toronto Transit Board Meeting  
July 10, 2019

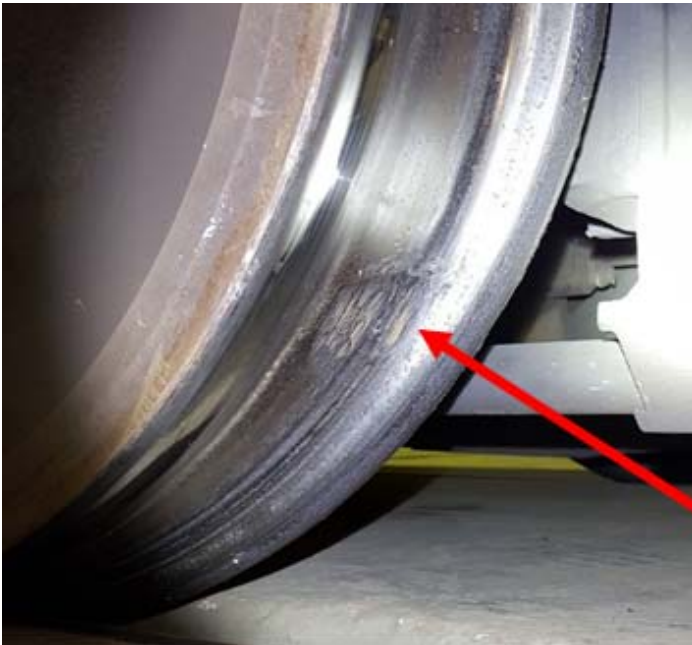
Flat Spot

- Wheel Flats Have A “Thumping” Sound & Generates Vibration
- Larger The Flat:
  - Louder the Thumping Sound
  - Greater the Vibration

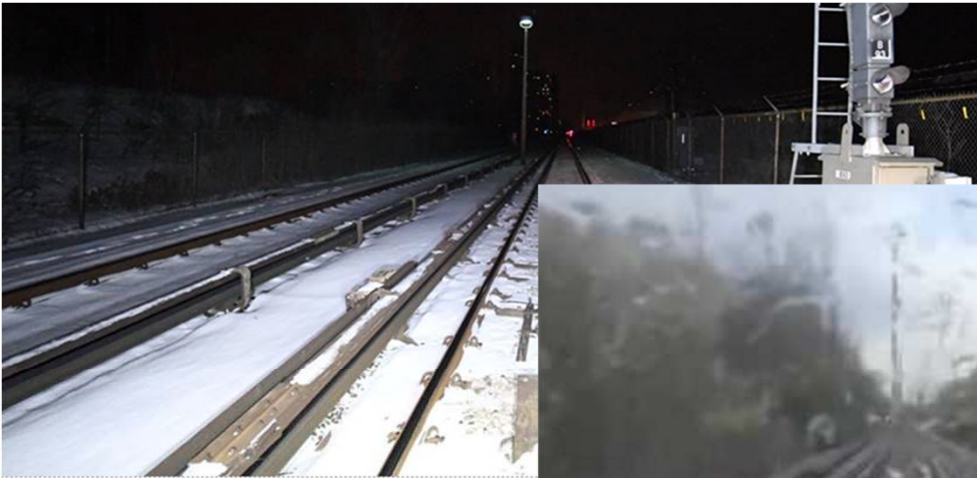
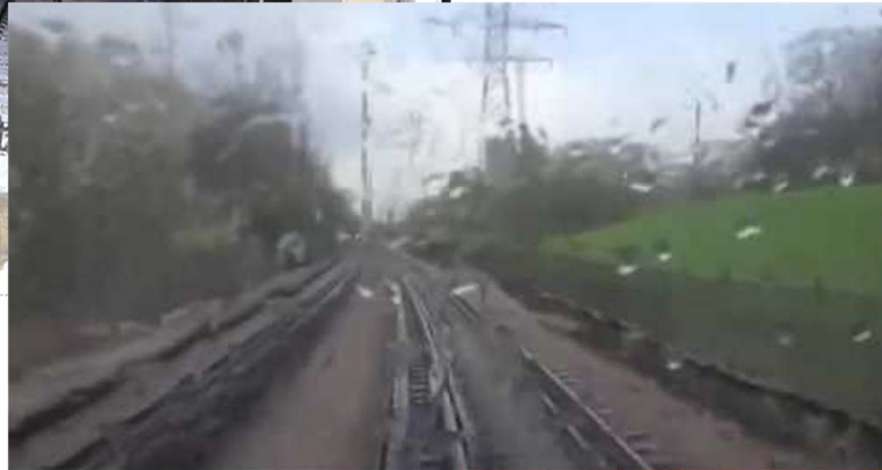
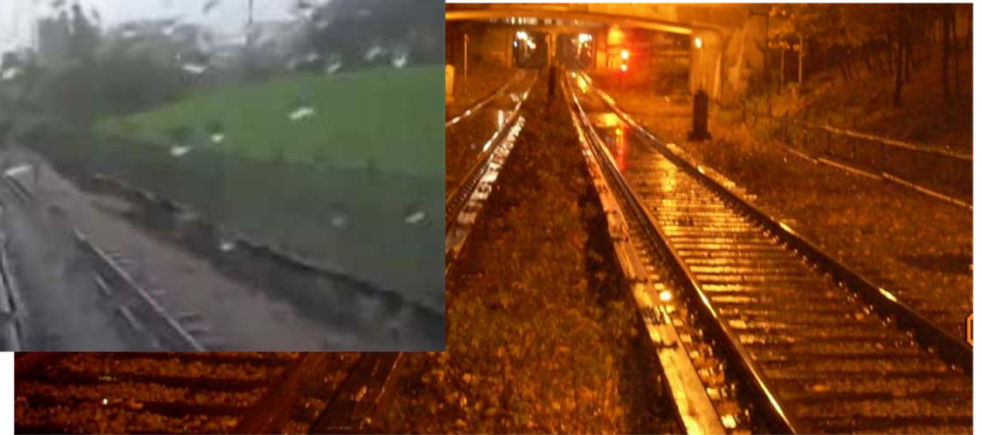
- Wet rail, leaves, snow, and over-lubrication can cause areas of low traction.

- ✓ *Cleaning of rail*
- ✓ *Turning off of lubricators – to eliminate grease as significant contributor*
- ✓ *Testing of top of rail friction modifier*
- ✓ *Added SCS and Un-Equipped Mode (UEM) tags*
- ✓ *Implementation restricted speed zones*

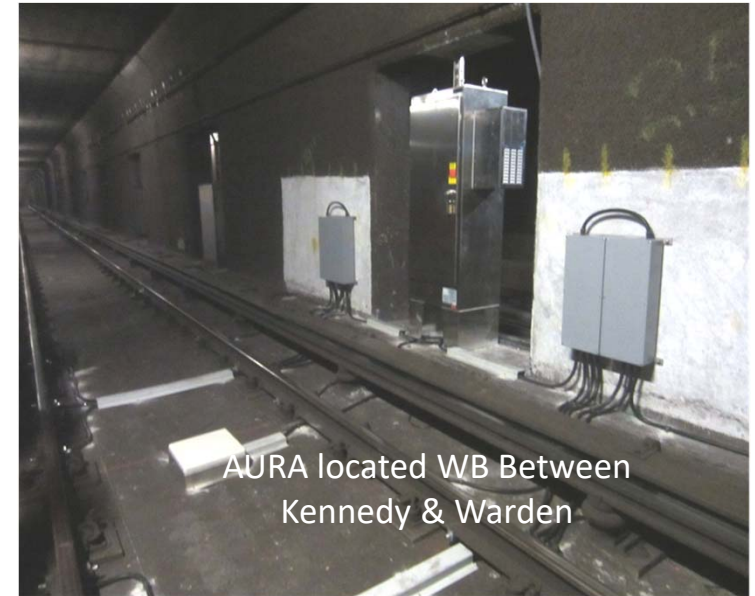
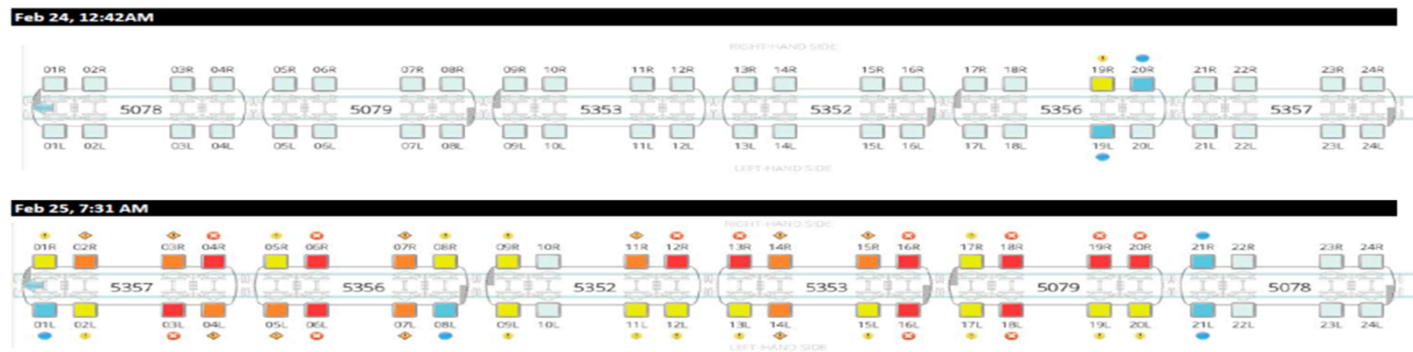
## AURA Wheel Flat Detection System

- Installed on Line 2 in 2012 and Line 1 in 2015
- Early warning detection system
- AURA identifies axles and color codes according to severity of wheel flat (RED = Most Severe)
- Trains with red flats are the most severe and are removed from service

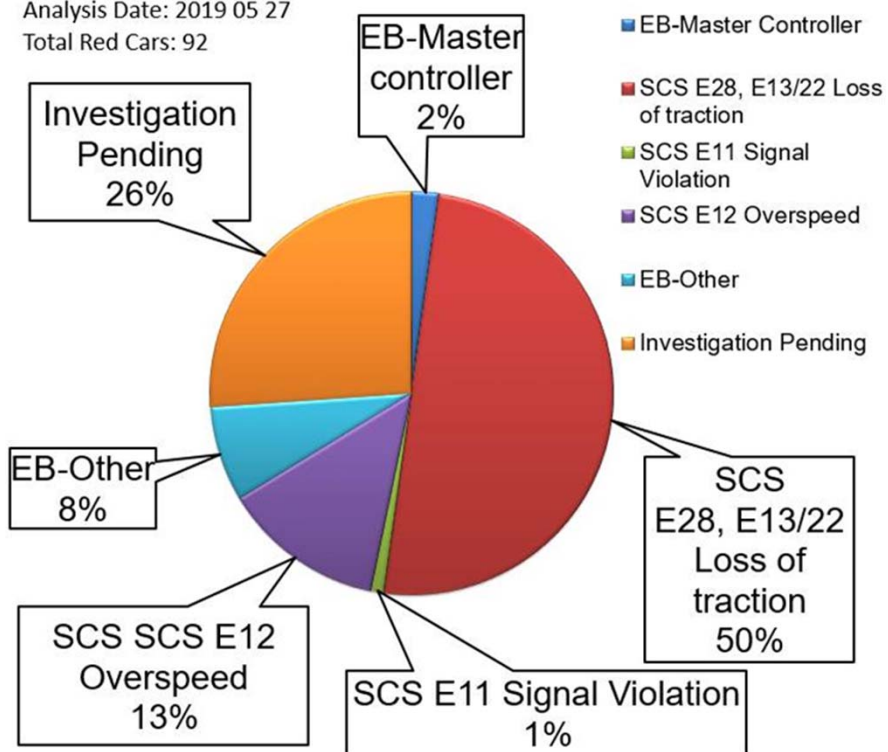
RED FLAT CARS BY EB EVENTS, APRIL 2019

Analysis Date: 2019 05 27  
Total Red Cars: 92

- EB applications monitored and reduced on some SCS codes
- Subway Infrastructure Engineering investigating potential improvements to SCS software
