SRT Incident Review and Subway Track Modernization

Board Meeting - April 11, 2024

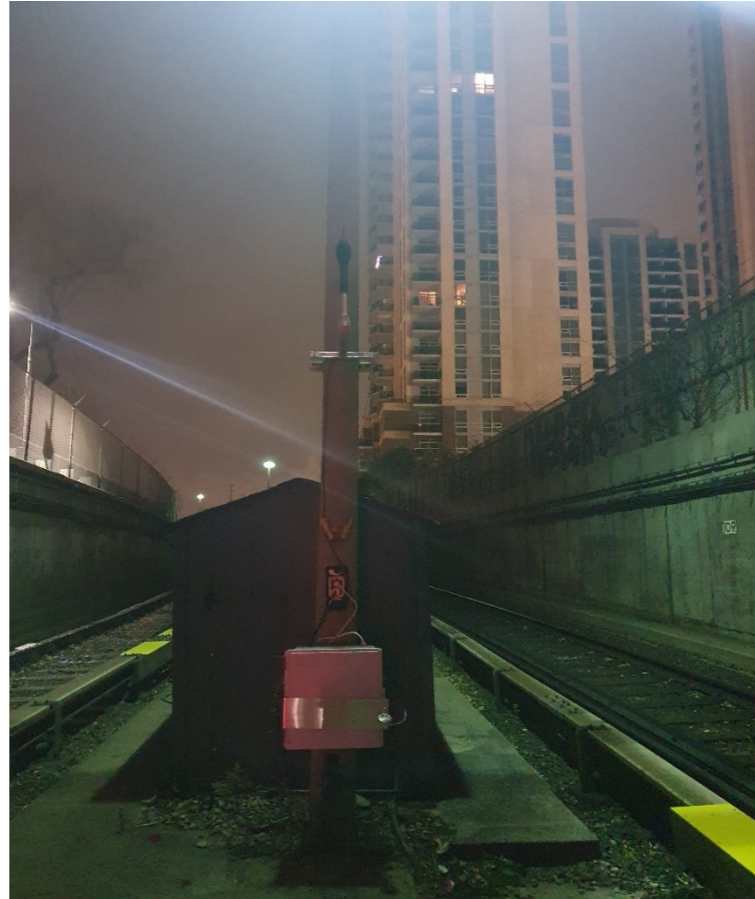
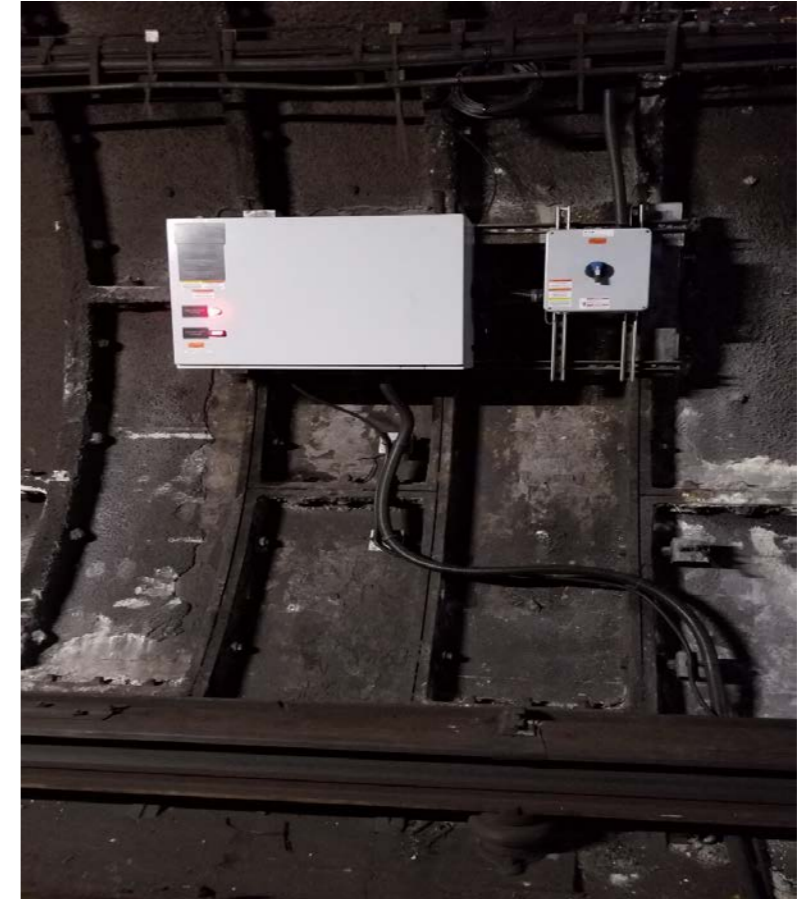
Noise and Vibration Real Time Monitoring

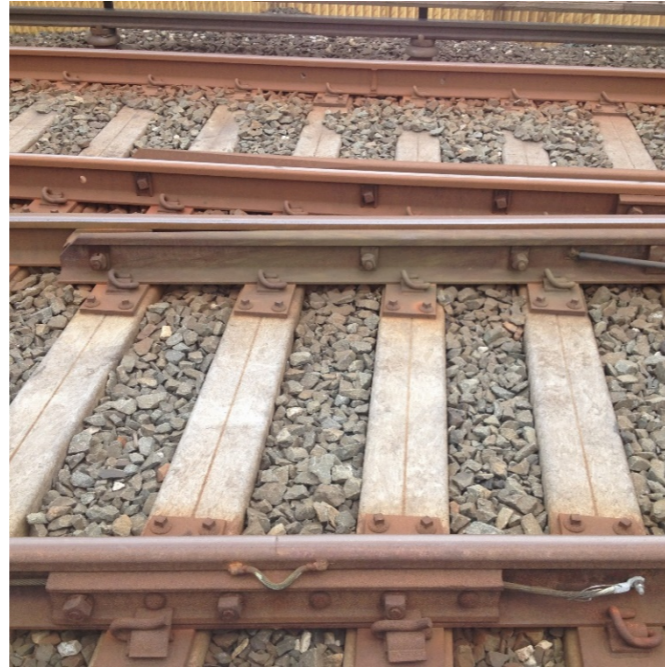
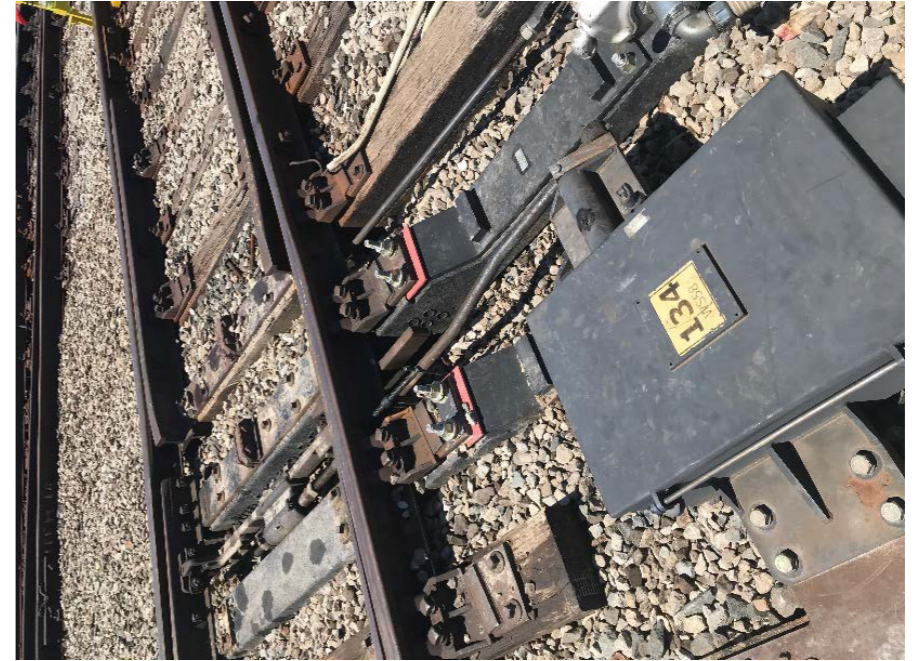
Traditional Wood Ties vs New Composite Ties
